Influence of Surface Roughness on Durability of New-Old Concrete Interface

Nurdeen Mohamed Altwair*, Younis Omran Yacoub, Abdualhamid Mohamed Alsharif, Lamem Saleh Sryh

Department of Civil Engineering, El-Mergib University, Al-Khums, Libya

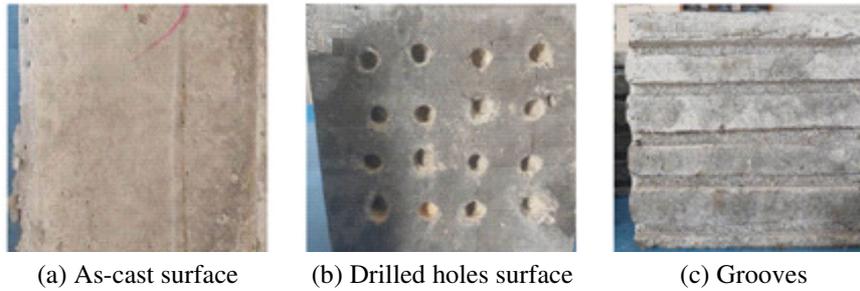
Fig. 1 Surface preparation

This study focuses on preparing concrete surfaces before applying overlay concrete. The test specimens consist of two identical layers of concrete: the existing plain concrete substrate (old concrete) and the new concrete overlay. The plain concrete substrate specimens are placed within a lubricated mold and allowed to remain in their molds at room temperature for 24 hours. After a 24 hours period, the plain concrete substrate specimens are thoroughly cleaned and subjected to a 28-day curing process in a water curing tank. After 28 days of being cast and cured in water, the specimens were removed from the water tank for surface preparation. Three methods of preparing the concrete substrate surface were used: CS (without surface preparation), GS, and DS, as shown in Fig. 1. Before applying the new concrete overlay, the old concrete specimens were fully immersed in water for one day and subjected to a drying period of 25 minutes. Subsequently, the specimens were placed into their respective molds, and then the new concrete overlay was poured and allowed to cure at room temperature for 24 hours. After 24 hours, the specimens were removed from the molds and subjected to water curing for 28 days.

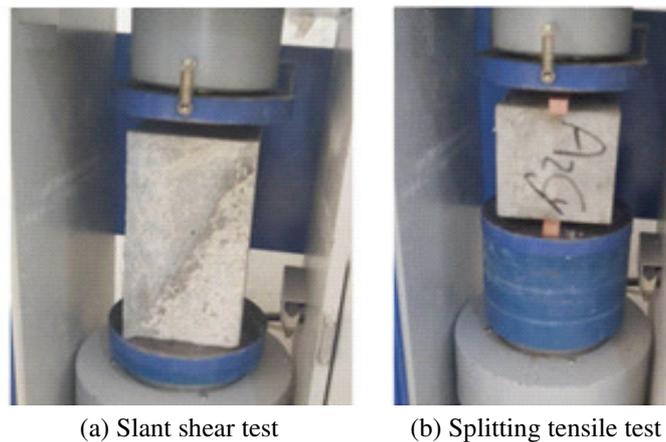
Fig. 2 Test setup

After curing for 28 days, the specimens were removed from the water curing tank immersed in NaCl solutions with mass concentrations of 5% for 30 and 60 days, and subjected to slant shear and splitting tensile tests. The slant shear specimens were designed with a prism shape measuring 15 cm × 15 cm × 30 cm (Fig. 2(a)). The specimens were tested under compression using the standard approach for assessing the compressive strength of cubes, as outlined in the ASTM C882 standard [16]. The splitting tensile test was based on the guidelines specified in BS EN 12390-6 [17]. As illustrated in Fig. 2(b), the specimens were modified from their original cylindrical shape to cubic specimens measuring 15 cm × 15 cm × 15 cm. In the particular experimental setup, using cubic specimens elicits the feasibility and efficiency to conduct a larger number of tests within the given time and resource constraints. Notably, both the cylinder-splitting test and the cube-splitting test yielded almost the same accuracy.

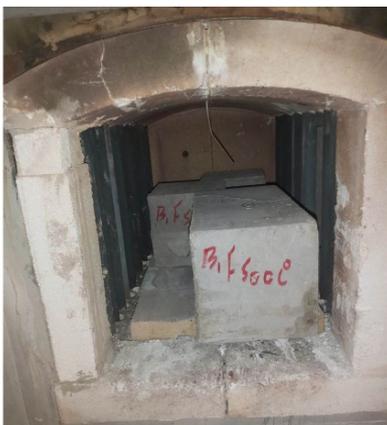
Fig. 3 An automatic electric furnace contains specimens

An automatic electric furnace was used for the heating of specimens with a constant heating rate of about 15 °C/min to reach the prescribed 200 °C and 500 °C temperature levels (Fig. 3). The temperature inside the furnace was maintained constant for three hours to achieve the thermal steady state condition after the target temperature was reached. After heating, the specimens were left at room temperature for one day before slant shear and splitting tensile tests.

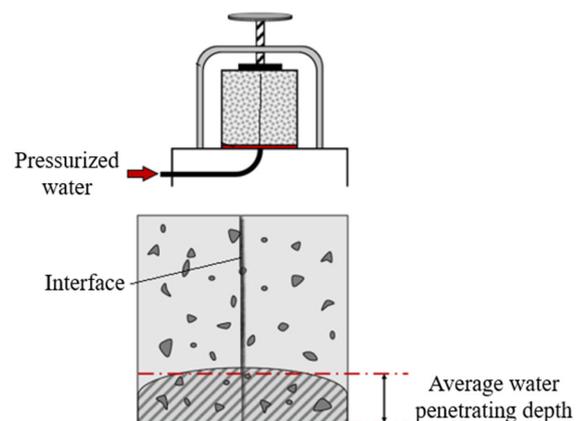
Fig. 4 Schematic view of permeability test

A water permeability test was conducted using cubic specimens with dimensions of 15 cm × 15 cm × 15cm, following BS EN 12390-8 [18]. The permeability testing procedure is schematically shown in Fig. 4. The test specimens were first placed inside the permeability cells, and then water was introduced on the lower face of the specimen. Meanwhile, a pressure head of 5.5 bars was applied in a direction parallel to the contact surface between the old and new concrete for 72 hours. Subsequently, the specimen was split in half perpendicular to the water pressure applied to the face. The maximum depth of penetration under the test area was recorded and measured to the nearest millimeter.

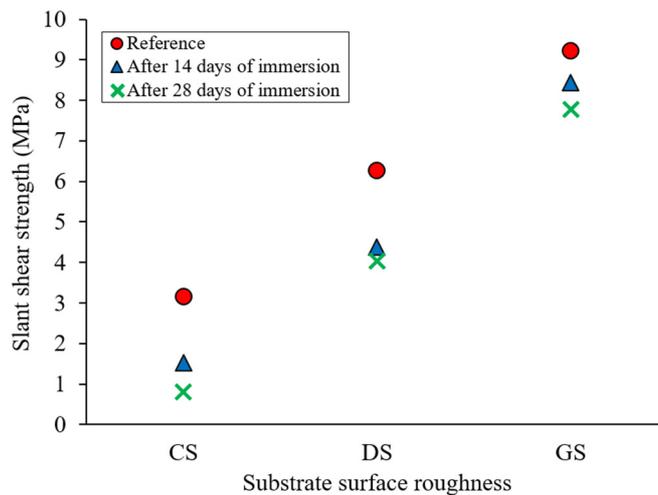
Fig. 5 The relationship between shear strength and surface roughness after 15 and 30 days of NaCl solution exposure

The slant shear test is a widely recognized method for measuring bond strength under combined compression and shear loads. Given its frequent deployment, moreover, it has been formally acknowledged by numerous international standards. Fig. 5 displays the experimental slant shear strength test results. It can be noted that the bond strength of specimens without a

roughening CS was found to decrease by 51% and 75% after 30 and 60 days when immersed in NaCl solution. Meanwhile, the DS specimens experienced a reduction of around 30% and 35% after 15 and 30 days, respectively. The GS specimens experienced a drop of around 8.6% and 15%.

The GS yielded a lower decrease in shear strength compared to other surface roughness methods. The GS exhibited an 81% and 90% increase in shear strength compared to the CS after 30 and 60 days of immersion in NaCl solution, respectively. The improvement also embodied a growth of around 49% to 48% compared to the DS at the corresponding ages. The ACI 546R-96 [20] specifies a minimum permissible slant bond strength ranging from 6.9 to 12 MPa. DS and GS indicated shear strengths within acceptable limits before being placed in NaCl solution. Furthermore, it was reported that the GS specimens, while being submerged in a NaCl solution for 60 days, exhibited shear strengths that fell within acceptable limits. These findings demonstrate that surfaces with varying types of roughness, such as DS and GS, significantly enhance the slant bond strength of the specimens in comparison to the control specimens.

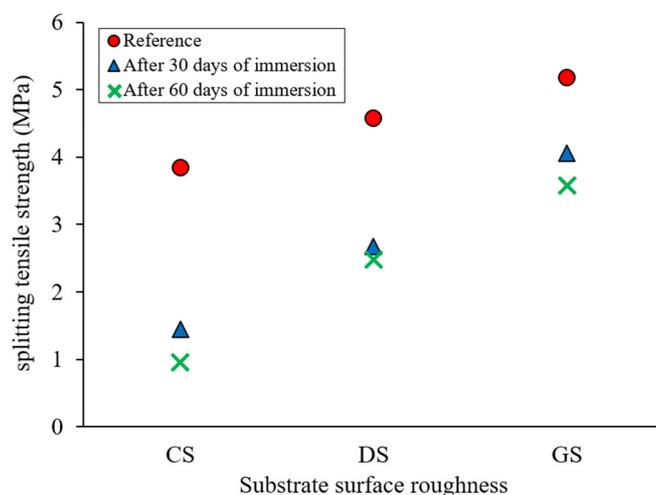
Fig. 6 The relationship between the splitting tensile strength and surface roughness after 15 and 30 days of NaCl solution exposure

Both DS and GS may be categorized as possessing exceptional bond strength since the bond strengths were more than 2.1 MPa. Furthermore, the findings concerning the impact of surface roughness were discovered to be highly consistent with those of Tayeh et al. [2], where the authors investigated various surface preparation methods for bonding ultra-high-performance fiber concrete to NC substrates to create repair composites. The researchers conducted a rapid chloride permeability test to evaluate the chloride resistance of the composites. Five different surface textures were employed for surface roughening, including no roughness, sandblasting, wire brushing, drilling holes, and creating grooves. The results highlight the significance of surface preparation in achieving a strong mechanical bond between the composites and the substrate. The composites that underwent surface treatment exhibited the highest mechanical bond strength, yielding an enhanced resistance against chloride penetration.

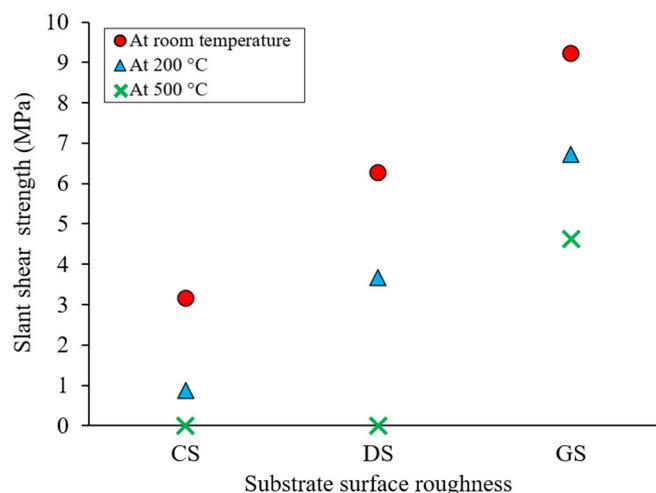
Fig. 7 The relationship between shear strength and surface roughness of specimens at 200 °C and 500 °C after 28 days of water curing

The effect of temperature on the slant shear bond is shown in Fig. 7. The slant shear strength level was found to be susceptible to temperature changes. As shown in the figure, surface roughness is of evident importance in resisting the effects of temperature. By comparing the methods used in surface treatment, GS, yielded the highest slant shear strength, whether at a temperature of 200 °C or 500 °C. The resistance of all the examined specimens to the effects of elevated temperature was observed at 200 °C.

The CS and DS specimens, however, failed at 500 °C, whereas the GS specimen remained resistant. Additionally, it is observed that the bonding strength of CS and DS decreased as the temperature increased due to the expansion emerging between the two layers of concrete and the development of thermal cracks on the composite surface, which also begot spalling at 500 °C. The results of the slant shear strength of CS, DS, and GS were 0.87, 3.67, and 6.73 MPa at 200 °C, respectively, while the slant shear strength of GS was 4.63 MPa at 500 °C.

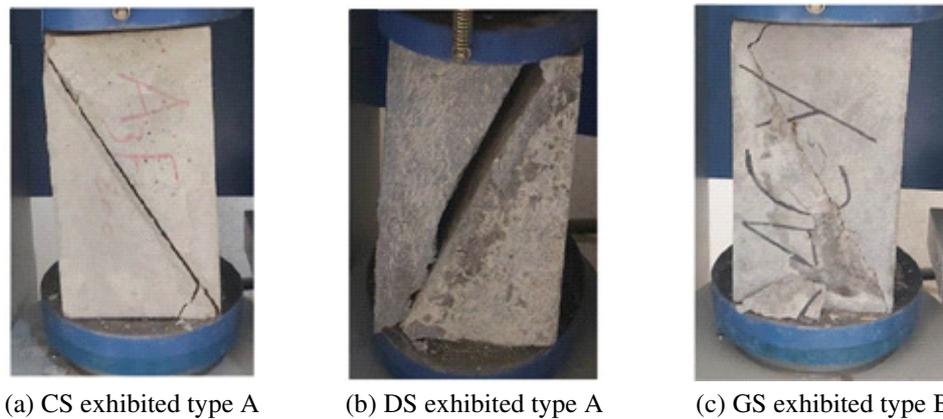
Fig. 8 Failure modes of specimens subjected to a slant shear test after exposure to temperature

Failure patterns emerging during a slant shear strength test can be classified into four categories: pure interfacial failure (type A), concrete substrate cracking (type B), interfacial failure in conjunction with substrate fracture (type C), and substratum failure with a good interface (type D) [15]. Encapsulate from the slant shear test results of this study, at 200 °C, all specimens with both CS and DS surface treatments were successfully categorized as failure mode type A, while the failure

mode in the GS, whether at 200 °C or 500 °C, was type B (Fig. 8). Furthermore, despite being subjected to temperatures significantly exceeding the average room temperature, the GS specimens exhibited satisfactory strength, as specified in the ACI 546R-96 [20].

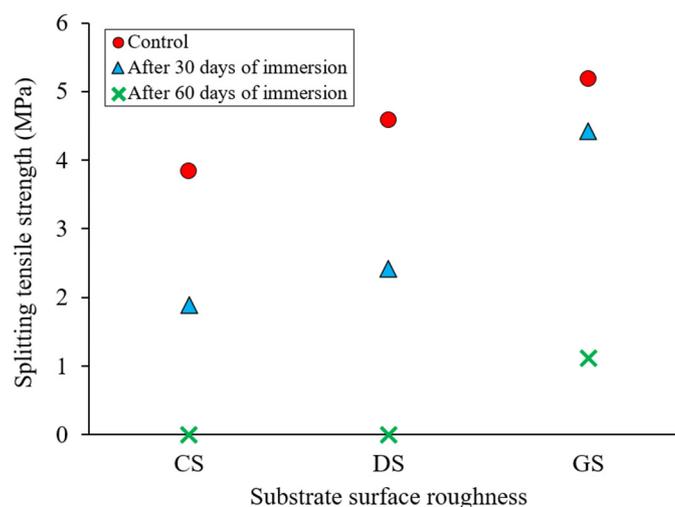
Fig. 9 The relationship between splitting tensile strength and surface roughness of specimens at 200 °C and 500 °C after 28 days of water curing

Fig. 9 depicts the splitting tensile strength of specimens with varying roughness after exposure to temperatures of 200 and 500 °C. The results of this test are consummately consistent with the scenarios concerning the slant shear test results. Observably, the percentage reduction in splitting tensile strength for CS, DS, and GS at 200 °C was 50%, 47%, and 14%, respectively.

However, both CS and DS failed before the specified duration of the test when exposed to a temperature of 500 °C, which is due to the development of thermal cracks on the composite surface and the decomposition of the concrete structure after exposure to high temperatures, physically and chemically, which begot spalling [15]. The splitting tensile strength of GS specimens experienced a decline of approximately 75%, which is deemed acceptable for withstanding the impact of such temperatures. The tensile bond strengths of specimens treated with GS at 500 °C ranged from 0.7 to 1.4 MPa (i.e., 1.12 MPa), indicating that the quality of bonding was satisfactory [2].

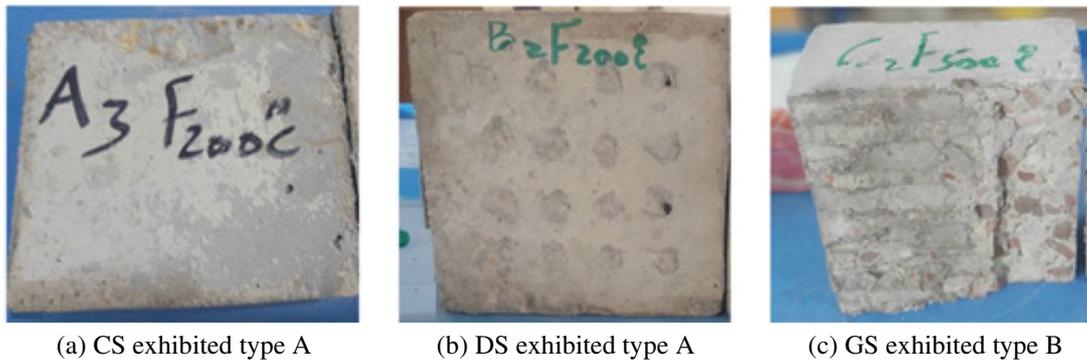
Fig. 10 Failure modes of specimens subjected to a splitting tensile test after exposure to temperature

Based on Fig. 10, the failure mode of the studied specimens in the splitting tensile test is similar to the failure in the slant shear test. In other words, at 200 °C, the CS and DS specimens had interface fractures, and no damage was observed either from the substrate (old concrete) or the overlay concrete (new concrete). Total specimen failure occurred when the crack in the specimens subjected to tensile stresses emerged from the middle of the interface, propagated on both sides and reached the top and bottom of the specimens.

Fig. 10(a) depicts the CS specimen subjected to the splitting tensile test. It can be observed that the concrete surface remained undamaged, and no additional damage was found on the surfaces (exhibiting type A failure). Fig. 10(b) illustrates DS specimens that underwent the splitting tensile test. During the test, a small portion of concrete was penetrated the cavities formed by the drilling process. The interface failure mode occurred between the surfaces, similar to CS specimens, which exhibited type A failure. Fig. 10(c) demonstrates the failure mode of the GS specimen under splitting tensile stress. The specimens had mixed-mode failure, which means minor substrate failure and interface failure occurred in specimens that exhibited type B failure.

Fig. 10(c) also reveals that the grooves provided significantly stronger bond strength compared to the substrate. It is palpable that the failure occurred partially within the substrate without complete separation or debonding between the substrate and the overlay concrete. The failure within the concrete substrate indicates robust bond proficiency, signifying that the strength of the interfacial bond is more significant than the strength of the concrete substrate. As stated by Hager [24], specimens exposed to a temperature of 500 °C consistently exhibit a gradual decrease in their bonding strength. This decrease is attributed to the rapid decline in the content of portlandite as it undergoes decomposition. Castellote et al. [25] further support this observation, reporting that the increase in CaO content in cement paste at 500 °C can be explained by the decomposition reaction of portlandite.

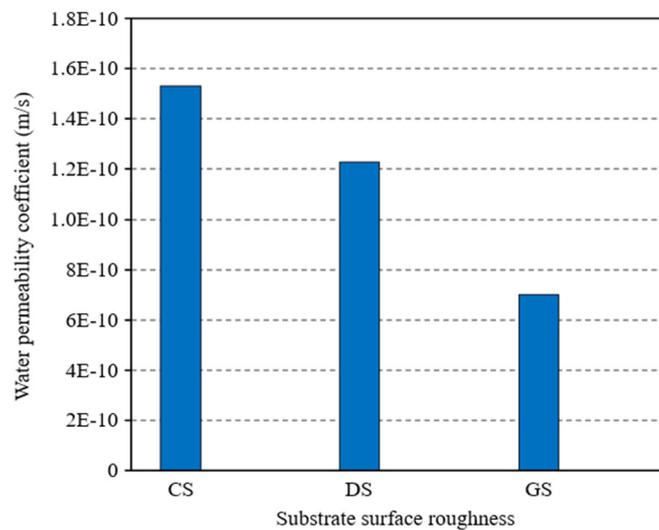
Fig. 11 Water permeability of specimens with varying roughness after 28 days of water curing

Fig. 11 depicts the water permeability of specimens with different surface treatments after 28 days of water curing. From this figure, it is evident that the surface roughness of the concrete substrate after treatment is the main factor affecting the permeability of the interface.

As presented in Fig. 11, it portrays that GS specimens exhibit a low value of water permeability, followed by DS specimens. It was found that the permeability coefficient was 1.5×10^{-10} , 1.2×10^{-10} , and 7×10^{-11} m/s for CS, DS, and GS, respectively. The percentage reduction in permeability coefficient values was approximately 20% for DS and 53% for GS compared to the permeability of CS. The grooved interface GS exhibits optimal impermeability due to its high interfacial

bonding strength, which effectively reduces water permeability. The GS specimens effectuate a high roughness of the interface, which can effectively improve the mechanical interlocking and chemical force of the interface [26]. However, the permeability coefficient values for GS specimens still fall within the range of water permeability coefficients typically observed in concrete with average quality (10^{-11} - 10^{-12} m/s) [27].

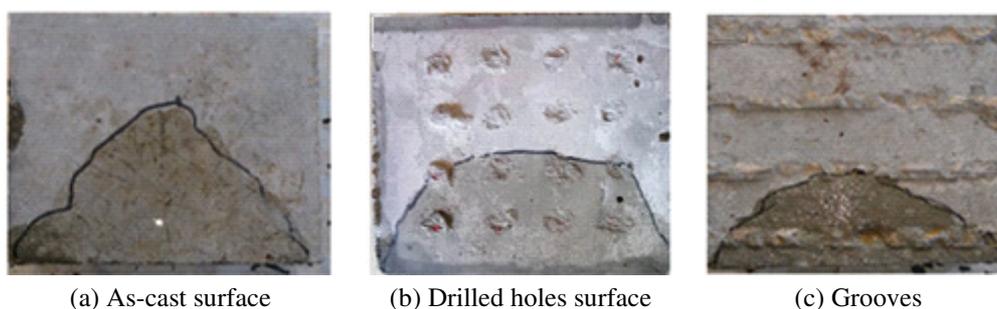
Fig. 12 Water penetration depth front marked after the test

Fig. 12 demonstrates that the permeability of the bond interface between old and new concrete is influenced by the treatments applied to the interface. The black line in the figures represents the water penetration depth of the specimen's cross-section. When the interface is adequately treated and results in a well-bonded surface combination, the impermeability is significantly improved, effectively preventing water penetration.

Additionally, Fig. 12 illustrates that specimens with different roughness, particularly GS specimens, demonstrated resistance to water penetration in comparison to specimens without roughness. The depth of water penetration was lowest in GS specimens, then DS specimens, and finally CS specimens. As previously mentioned, the reason for the prevention of water penetration on rough surfaces, particularly in GS specimens, can be attributed to the presence of grooves that create a more intricate and interlocking surface profile. When water comes into contact with the bonding zone, the grooves enhance the mechanical interlocking between the layers. These grooves introduce irregularities that amplify frictional forces, producing more bonding strength. This mechanical interlocking significantly contributes to additional resistance against water penetration.
