# **A Study of the Bolt Connection System for a Concrete Barrier of a Modular Bridge**

## **Abstract**

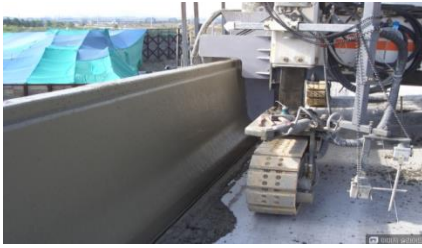
Fig. 1 Slipform machine

Examining the current state of barrier constructions in Korea reveals that there are two methods for cast-in-place constructions, one of which utilizes the onsite formwork, and the other which employs a slip-form machine (as shown in Fig. 1). However, both construction methods have problems. The former is expected to delay the duration of installation and dismantling of the formwork, whereas the latter is inconvenient for a construction on a bridge. Moreover, the aforementioned cast-in-place construction has a disadvantage that the barriers would be required to repair because of unexpected concrete cracking and collapse as depicted in Figs. 2 and 3, respectively. In recent years, studies on precast prefabricated bridges have been actively conducted regarding the use and installation of barriers with wall forms. Using a slipform machine has many demerits, such as the maintenance costs, in instances when it either requires some repairs, or when construction delays are associated with the problems outlined above. In addition to the consideration of the connection with other members it seems to be impossible for the slipform machine to be applied to prefabricated bridges. While one of the advantages of prefabricated bridges is the ease of their replacements, cast-in-place barriers are impossible to be removed. Thus, research on the methodologies adopted to connect the girders to concrete barriers for application in prefabricated bridges is essential. In this study, a prefabricated concrete barrier was presented and the connection systems were examined using experimental methods.

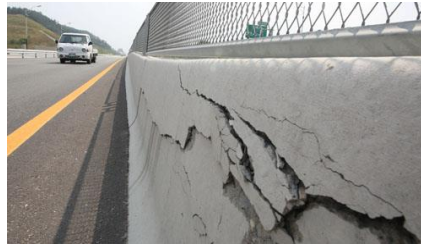
Fig. 2 Crack in barrier

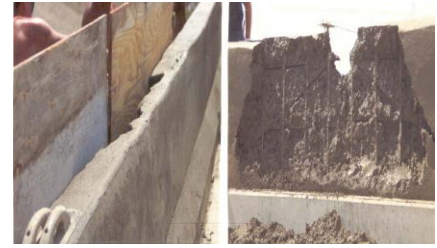
Fig. 3 Barrier collapse

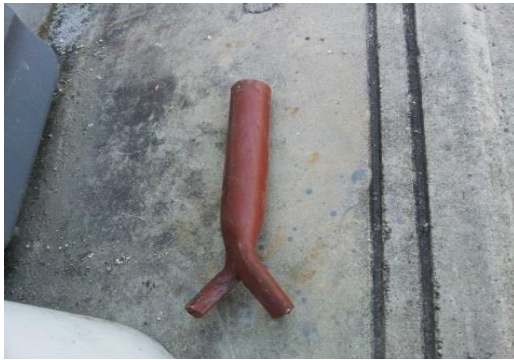
Fig. 4 Shape of nut

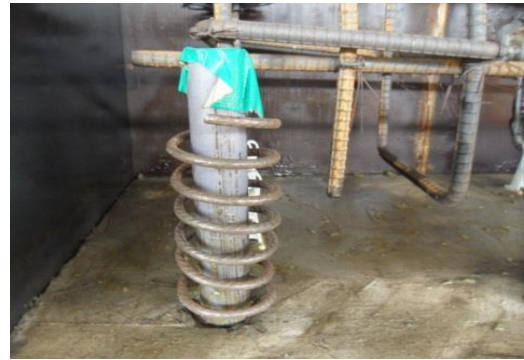
Fig. 5 Shape of spiral bar

The variable for the static experiment is in the form of the bolted connection between the deck and barrier, as presented in Table 2. Accordingly, three types of test specimens were produced: existing cast-in-place solid-body types (ST), vertical connections (VC), and horizontal connections (HC) between the barrier and the deck. The number of productions and bolts for each test specimen are listed in Table 2. To examine their applicability for a modular bridge, they were cast together with nuts embedded in advance. The nuts used here are shown in Fig. 4. To prevent local failure around the bolts during loading after the installation of the concrete barrier and deck, spiral bars were used as depicted in Fig. 5.

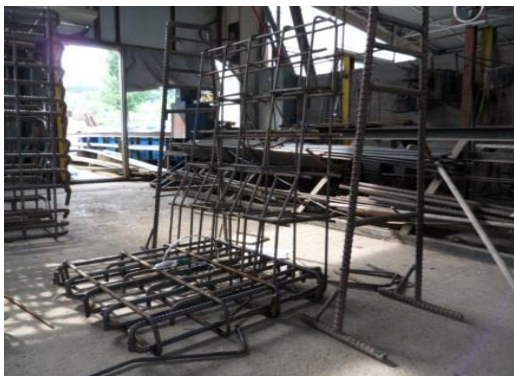
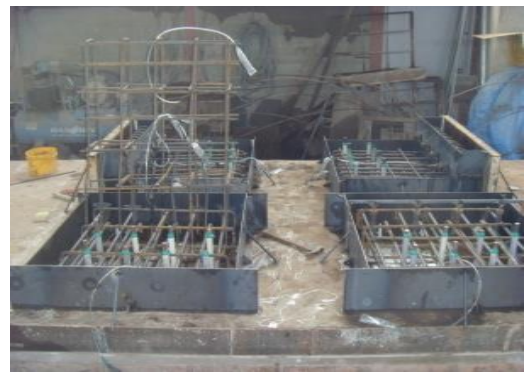
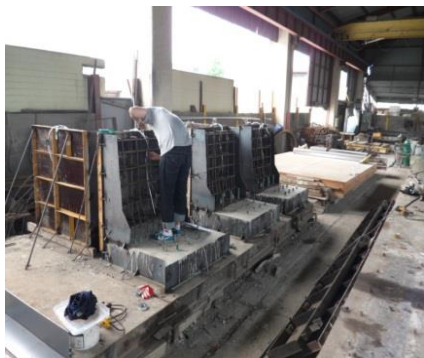
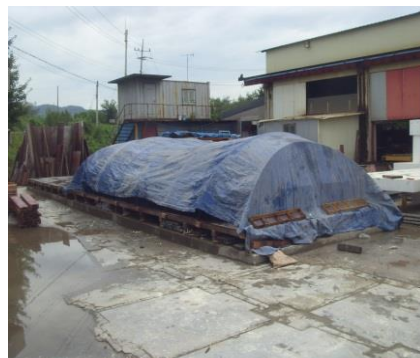
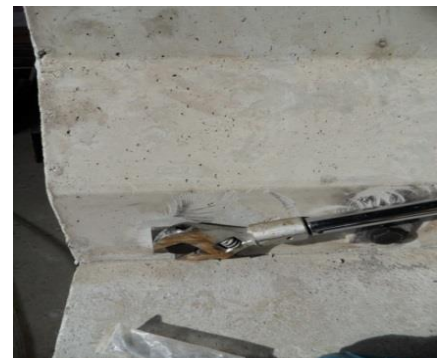
(a) Installation of bar

(b) Installation of cast and placement of concrete in the deck

(c) Installation of cast and placement in the barrier

(d) Steam curing

(e) Connection of barrier and deck

Fig. 6 Adopted procedure for building specimens

The test specimens were produced in a series of processes as illustrated in Fig. 6. The details of the specimens according to the type of connection are displayed in Fig. 7. The ST specimen was produced as follows: after the fabrication of the bars in the deck and barrier, concrete was first placed on the deck, and the concrete used for the barrier was then poured. Both the VC and HC specimens were produced by the match-casting construction method. The construction sequences are as follows: first, the shuttering of the deck was installed after fabricating the reinforcement followed by the placement and curing of the concrete. Once the deck concrete cured, the barrier formwork was installed on top of the deck and the concrete was poured and set. Moreover, to maintain the initial wet condition of the concrete after casting without the harmful effects of low temperatures, dryness, and rapid temperature changes, the test specimens were hardened by steam curing and fabricated by a torque wrench.

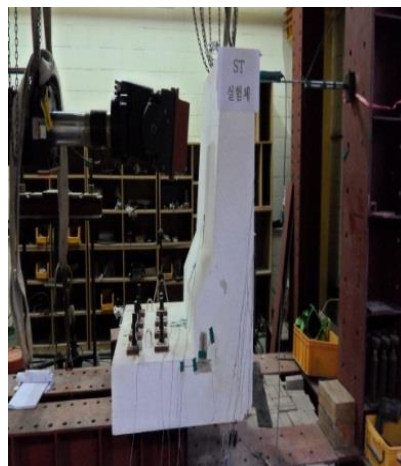
Fig. 8 The shape of an actuator

The form of the static loading experiment on the barrier is similar to that of the colliding surface in an automobile collision. The Korean Highway Bridge Design Code (2005) suggests the consideration of the estimated horizontal collision force as a uniformly distributed load at a constant height in reference and usage to the deck design. The American association of state highway and transportation officials (AASHTO) loads & resistance factor design (LRFD) Bridge Design Specifications (2007) provides relatively detailed information on the form of loading and on collision loads. However, the experiment in this study was focused on the structural performance of the connection system and not on the barrier itself. Additionally, the test specimens were also produced with unitary (1 m) lengths. Thus, a concentrated load was applied until failure occurred according to the AASHTO specifications. The load was applied at a height of 810 mm for controlling the displacement at a rate of 1 mm/min using a 500 kN actuator. Load cells were installed to obtain accurate loading data, and the system of loading test pieces is that shown in Fig. 8.

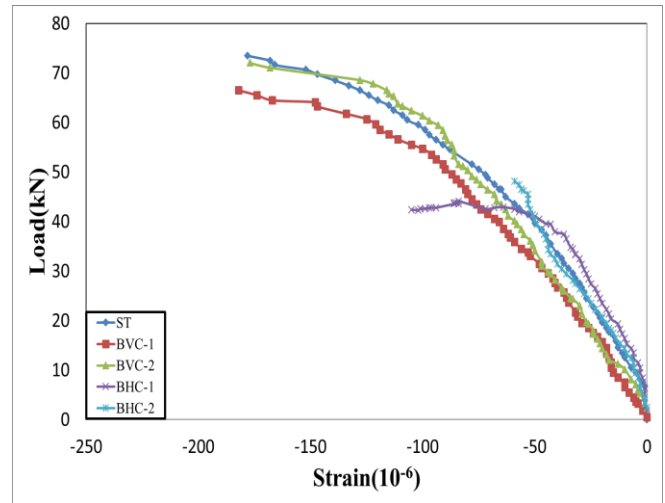
Fig. 15 Strain curve at GC7

Fig. 15 illustrates the load-strain curve measured by the GC3 concrete gauge, which was attached on the rear side of the barrier. Because GC3 was placed at the largest compressive strain, the VC and HC specimens showed a relatively less significant

strain compared with the strain of the ST specimen. This is because the bolts at the connected surface were pulled out as the applied load increased. Moreover, this circumstance led to the disconnection of the barrier, but the compressive force did not affect the rear side of the barrier of the VC and HC specimens apart from the ST specimens.

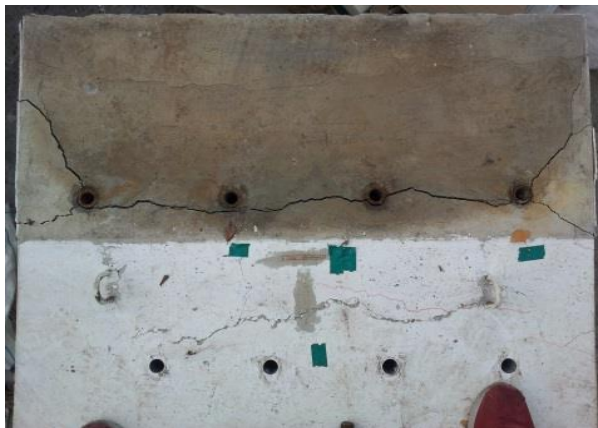
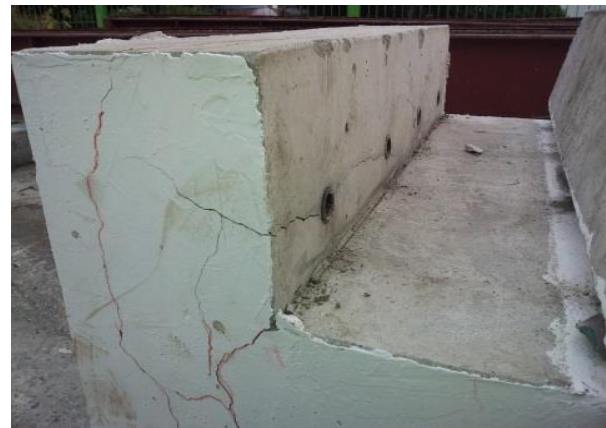
(a) VC connection

(b) HC connection

Fig. 17 Crack patterns at the connected surface

For the HC specimens, the initial crack in the deck has a similar crack pattern, but as the loading increases, a separation between the connected surfaces occurs, and the distance between the connected surfaces continues to increase until the maximum load is reached. The crack patterns at the barrier could not be investigated. Vertical cracks are created at the intersection between the barrier and the deck's edge as the distance of the separation increases. Additionally, without increasing the load, the crack width increases with time. The barriers and decks of the VC and HC specimens were respectively separated to investigate the crack formation at the intersection between the deck and the barrier. Consequently, the embedded nuts prior to the deck casting are observed to be pulled out, thus suggesting that significant cracking occurred around the nuts. This is as shown in Fig. 17.

- (3) Test specimens were separated to examine the crack patterns at the decks of the VC and HC specimens in which the nuts were embedded. There was almost no pull-out of the nuts, but significant cracking was observed around them. These findings suggested the necessity of using a reinforcing material to prevent the local failure around the nuts.
