Quantifying the Influence of Surface Roughness on Concrete Overlay Bonding in Sulfuric Acid Environments

Nurdeen Mohamed Altwair*, Younis Omran Yacoub, Alhussin Faraj Aliwan, Waled Faraj Alnaas, Saleh Elmahdi Abdulsalam, Abdualhamid Mohamed Alsharif

Department of Civil Engineering, El-Mergib University, Al-Khums, Libya

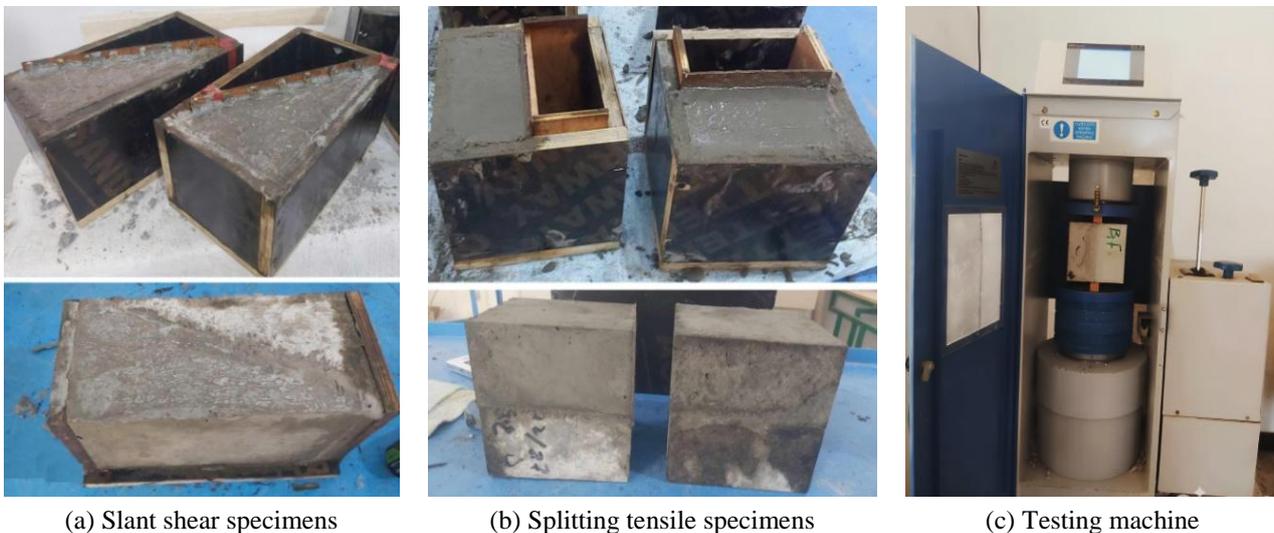
Fig. 1 Specimens and testing machine used in this study

The test specimens consisted of two congruent concrete layers: a normal-strength old concrete representing the existing substrate, and a repair layer of matching composition and grade (Fig. 1 and Table 3). These substrates were initially cast in lubricated molds and cured at room temperature for 24 hours, followed by demolding and a 28-day water cure. After this initial

Slant shear specimens were prismatic, measuring 150 mm x 150 mm x 300 mm, with an interface line inclined at 30° to the vertical (Fig. 1(a) and Fig. 3). Compression testing followed ASTM C 882 standards, applying a constant loading rate of 0.50 MPa/s. Bond shear strength (f_s) can be obtained by:

The tensile splitting test, conducted per ASTM C496 standards, assessed bond strength using cubic specimens measuring 150 mm x 150 mm x 150 mm (Fig. 1(b) and Fig. 4). This straightforward test yields more consistent results than other tension tests, with failure occurring due to indirect tension along the interfacial layer. A continuous loading rate of 0.05 MPa/s was applied. The splitting tensile strength (f_t) can be calculated assuming uniform tensile stress across the bond plane by:

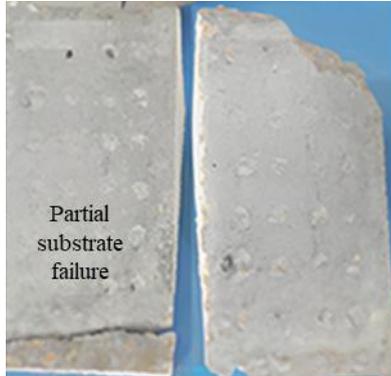
(a) CS-type A failure (0 & 15 days)

(b) DS-type B failure (15 days)

(c) GS-type B failure (30 days)

Fig. 6 Typical failure modes of slant shear specimens

coupled with substrate fracture. Finally, Type D failures involve substratum failure while maintaining a robust interface bond [4, 22]. The slant shear composite specimens exhibited two distinct failure modes upon testing, as illustrated in Fig. 6.

Type A failure was characterized by complete interfacial debonding at the transition zone, while Type B involved interfacial failure along with substrate cracking or minor damage. Notably, the CS surface consistently displayed Type A failure behavior, both before and after immersion in sulfuric acid, which corresponds to the lowest recorded shear bond strength due to insufficient substrate preparation. In contrast, the majority of failure modes for DS and GS surfaces were Type B, although DS specimens exhibited Type A failure after 30 days of sulfuric acid exposure. This mixed-mode failure, featuring partial substrate failure, correlates with the higher bond strengths observed for these treated surfaces, indicating improved interfacial adhesion. The varying surface roughness treatments significantly influenced the observed failure mechanisms, which correlated with the measured slant bond strengths. Specifically, the GS surface demonstrated the maximum slant bond strength, consistent with the Type B failure mode characterized by interface failure and partial substrate failure.

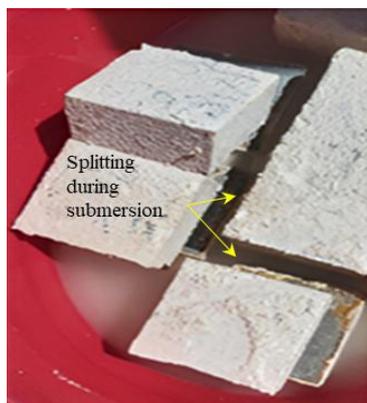
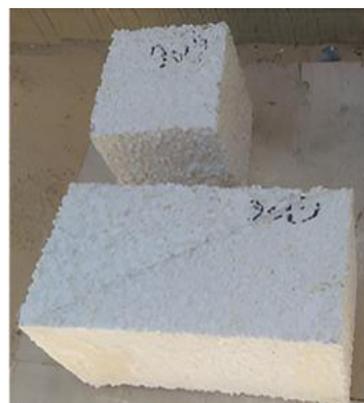
(a) CS-completely split (5 days)

(b) DS/GS-increased aggregate exposure (7 days)

Fig. 11 Specimens submerged in the 5% sulfuric acid solution

From the first day of exposure, a white powdery substance (specifically recognized as gypsum) gradually accumulated on the surface of all specimens, without any significant variations seen among them. The continuous extraction of gypsum resulted in an off-white residue at the bottom of containers, resembling the consistency of freshly mixed cement paste. Following three days of immersion, the CS specimens started debonding. After 5 days, all of the CS specimens split (Fig. 11(a)). By the end of the first week of immersion, the DS and GS specimens displayed exposed aggregates. As the acidic reactions continued, the aggregates were much more exposed (Fig. 11(b)).
