# Earth Dam Monitoring by Using Infrared Thermography Detection

Infrared thermography is applied for artificial earth dam surface monitoring. Using an infrared thermal imager is a nondestructive testing method for determining internal material changes by examining surface changes in radiation temperature. This study was conducted at the artificial earth dam experimental test site located in Landao Creek in Huisun Forest, Nantou County, and central Taiwan. Infrared thermography analysis found different zones with larger radiation temperature changes. The seepage caused the earth dam soil to be wet, as can be reflected by thermography. The seepage failure zone was found to coincide with dramatic changes in radiation temperature recorded using thermography. This study found that dam surface areas with large radiation temperature changes could be failure areas, and that the potential earth dam failure mode could be identified.

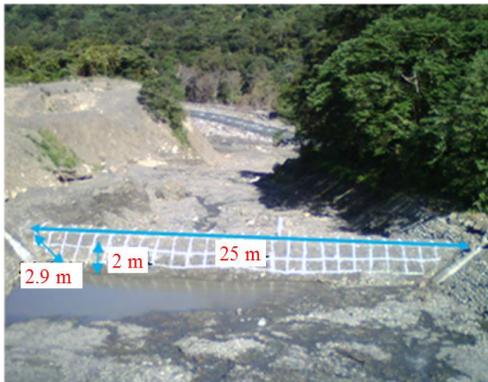
An artificial earth dam was constructed to model a landslide-induced earth dam (Fig. 2). The field test was located at the downstream of the creek. The artificial earth dam was constructed to be 25 m long and 2 m high. The discharge was released upstream toward the earth dam. The dam failure process was monitored using the infrared thermography detector.

Fig. 2 Size of the artificial earth dam
